(Delayed) Regarding the response to the problem with the indication of
a wheel released by AUTOWAY Co., Ltd.

Regarding the response to the problem with the indication of a wheel released by AUTOWAY Co., Ltd.

1. Regarding the locus of the problem (the wheel has a required level of durability, but its indication was problematic.)

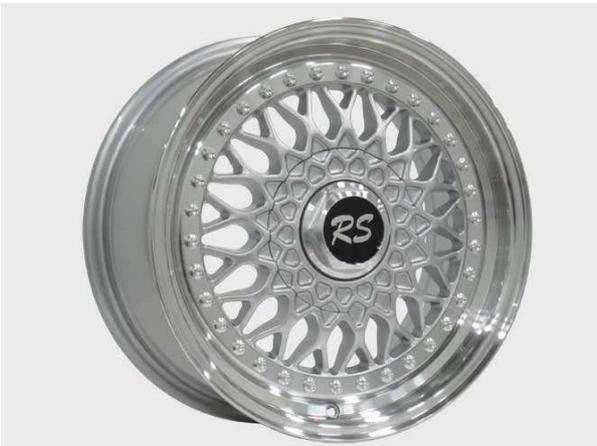
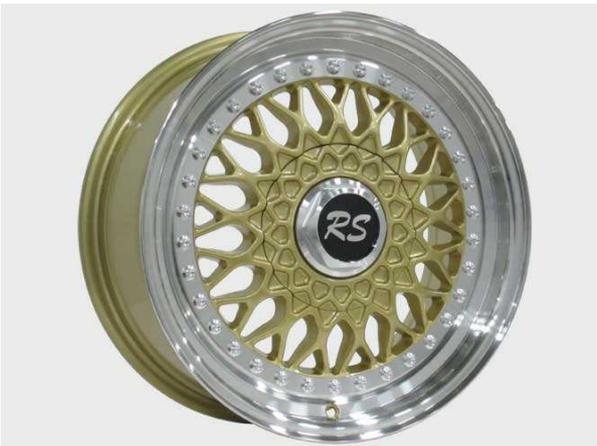
Appendix 1

Since RS-601 is a wheel to be used under the conditions for limited use, it is necessary to indicate "the symbol representing a vehicle" in addition to the "JWL" mark on the wheel as mentioned above. Meanwhile, RS-601 had only the "JWL" mark, as if it was to be used under the conditions for general use, although a test under the conditions for general use was not conducted (as mentioned above, the test under the conditions for limited use was conducted, and it was confirmed that RS-601 satisfies the conditions).

Photos of RS-601

Since RS-601 and wheels mentioned in Appendix 4 had inappropriate indications although they have required durability as described above, AUTOWAY will replace them with other wheels free of charge or refund money back to the customers who have purchased any of them. The cumulative total number of wheels subject to the charge-free replacement or refunding is about 37,000.
